# Case study: Stable sealing performance against oxidizing fluids

## TOMBO™ No. 1891-NM Kammprofile gasket

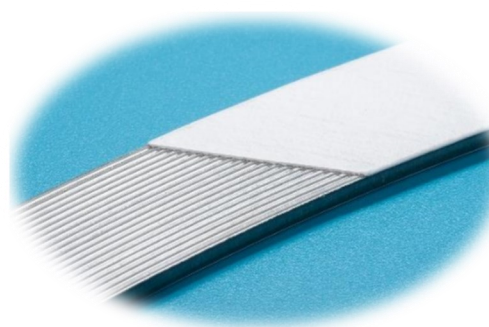
TOMBO™ No. 1891-NM Kammprofile gasket

Kammprofile gasket is a semi-metallic gasket with concentric grooves on both sides of a metal ring and NM sheet attached as a surface material. Therefore, it does not require a reinforcing inner ring like spiral wound gaskets. In addition, NM sheet has excellent oxidation fluids resistance. Weight loss when exposed to HTS is the same as other products on the market. Ultimately, by adopting TOMBO™ No.1891-NM, the customer reduced the risk of gasket damage and subsequent leakage due to oxidation, and acquired a stable sealing performance.
